# Landcare Benchmarking

Address: ..... *Knockalong, Tombong Rd, Delegate 2633* .....

## Description of debilitated area

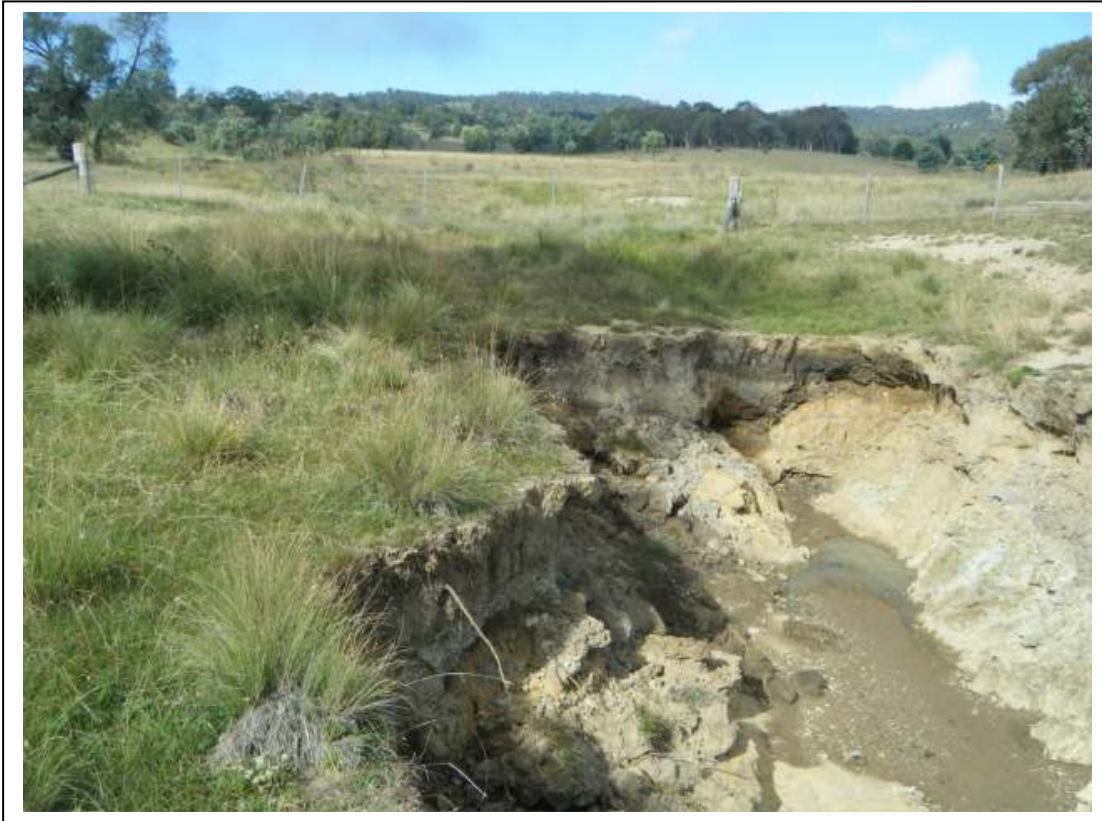
...*Active erosion gully 2 metres deep at it's head. Approximately 65 metres long. Situated 8 metres from a subdivision fence. The head of the gully is advancing an average of 1 meter per year* .....

**Head of the erosion area. Has advanced 1.5 meters in the last 2 years**

*Construction of a diversion bank 12 metres above the head of the erosion at the position of the existing fence line. The bank will divert the water to a gradual falling slope that runs parallel to the existing eroded gully. A smaller retaining bank will be built part way down the new flow area to prevent the water flowing back into the lower part of the eroded gully. The earth works in this area needs to be completed and the rehabilitation of ground cover established prior to the commencement of Stage 2. A new fence with a floodgate is to be erected over the diversion bank & spillway area. Topsoil will be spread on the exposed earth areas and grass seed sewn & watered in to start the regeneration process. Parallel with the flow of water, a “fabric” wall will be erected (100metres) on the higher ground. This will increase the volume of the diverted water without disturbing the top surface as would be the case in an earthworks situation. The “wall” will be curved and tensioned between two strainer posts using plain wire, netting & Terrastop 1380.*

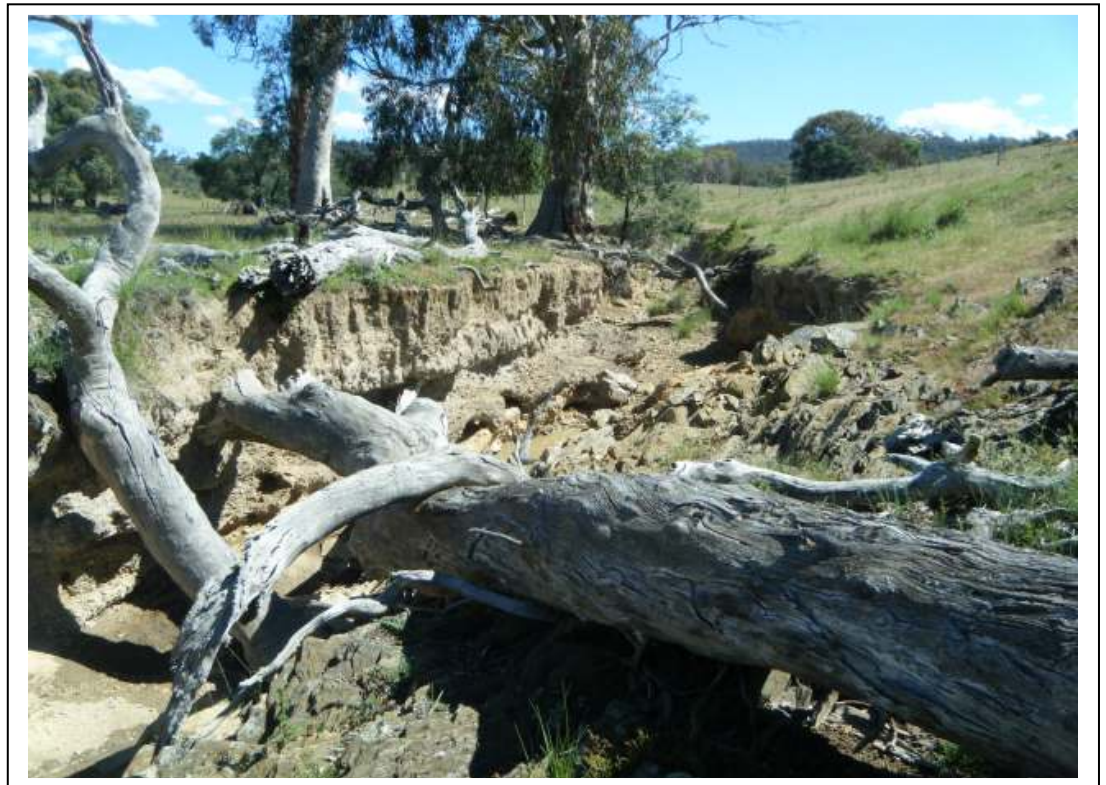
**Lower section of the erosion area**

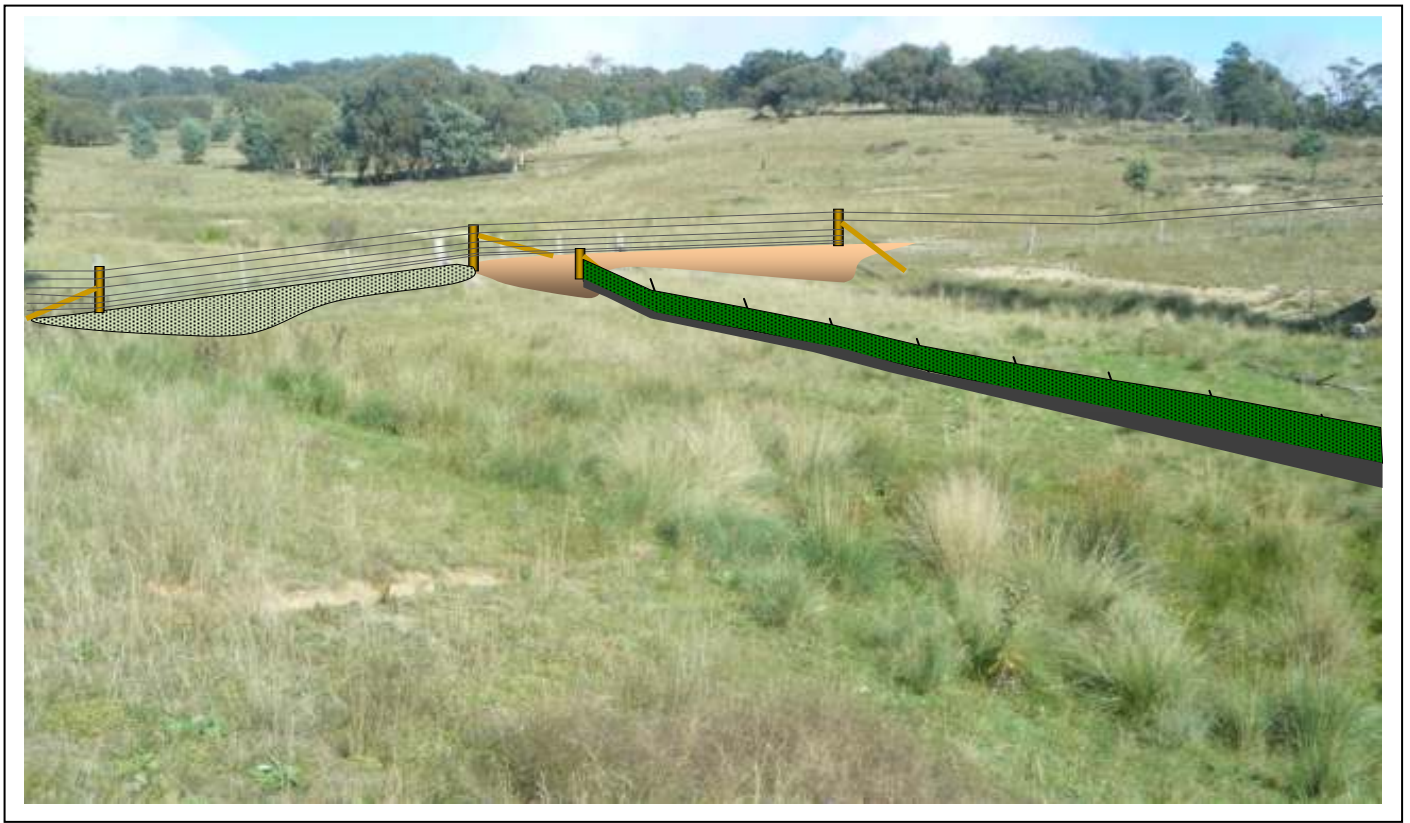
**Upper diversion area with diversion bank. Stage 2.**

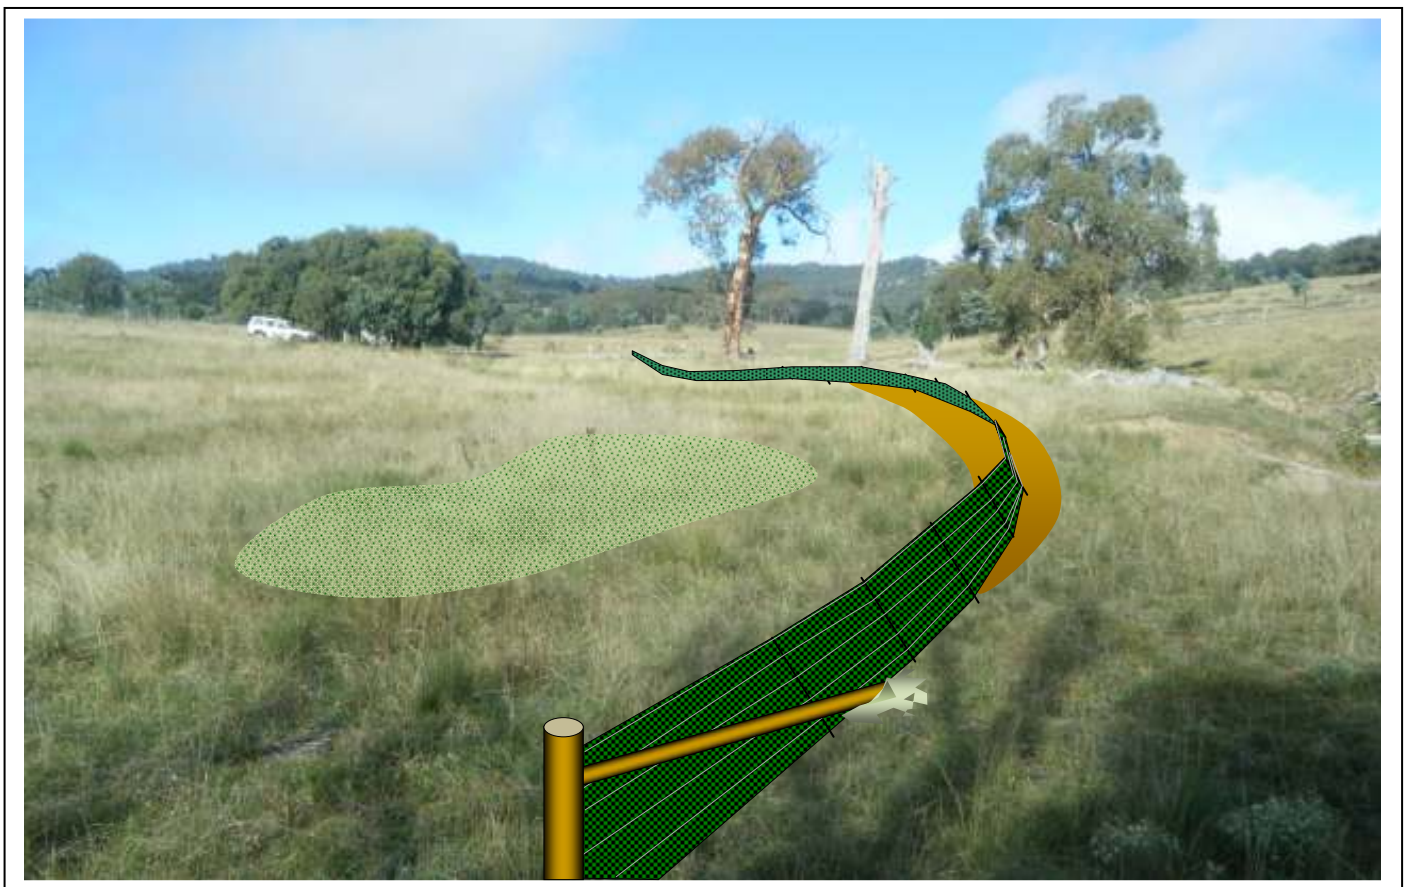
**Lower diversion area with bank & restablished grasses. Stage 1.**
