Project Report

Report on completion of Landcare Project for which in-kind work conducted:

Landcare – Sustainable Practices 2009/10

“Self-watering” native tree/shrub re-establishment Sites

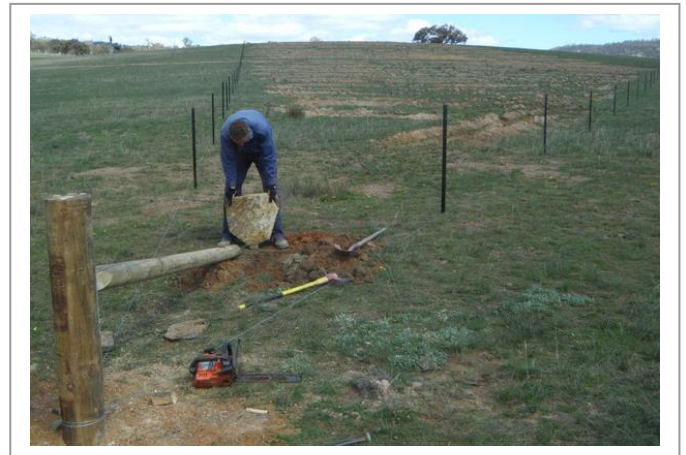
Site 4

Unfortunately a number of strainers were ejected from their holes. This was due to the clean form of the post unable to hold in the soil when the moisture entered through the slight opening caused by contracting soils. This was resolved by driving large metal pins into the bottom of each post.

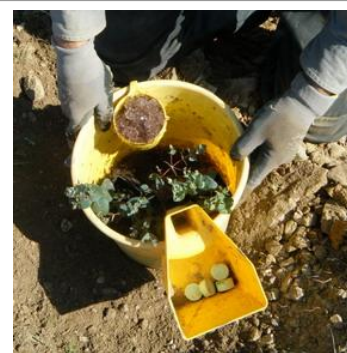
Rocky soils

Each planting required the digging of a hole in the base of the channel, followed by the formation of the side walls that would hold the first watering (20 liters). The local ground preparations for tree planting required the addition of top soil brought in as some areas were more rock than soil.

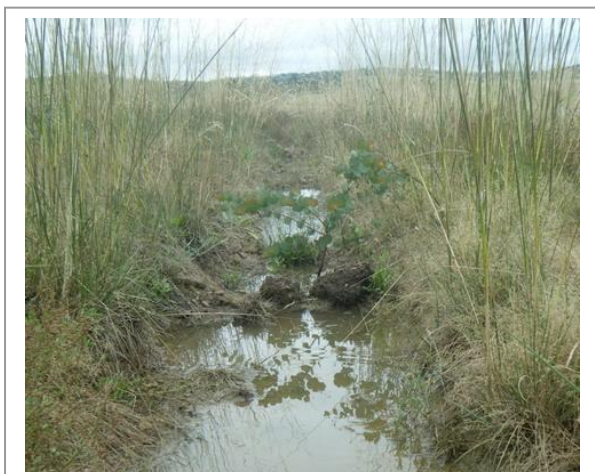
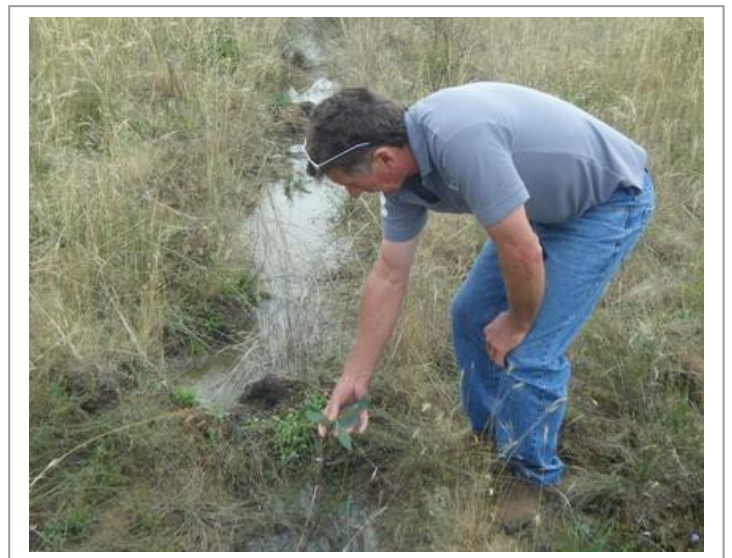
“Unfortunately” we had some wet periods through winter and more than 50% of the trees planted in Autumn 2010 were waterlogged and died. The dead trees were replaced where possible with the same species or else with Cassinias or Rubidas. The Rubidas were supplied in forestry tubes and the Cassinias in hiko trays. Once again the wet returned for the spring and the trees were once again flooded for extended periods.

In February 2011 the sites were inspected only to find that only 10 to 15% of all trees in the irrigated areas (sites 1 to 4) had survived in spite of the fact that the water flows in the feeder channels were diverted. 80 to 85% survived in the non watered site (No 5).

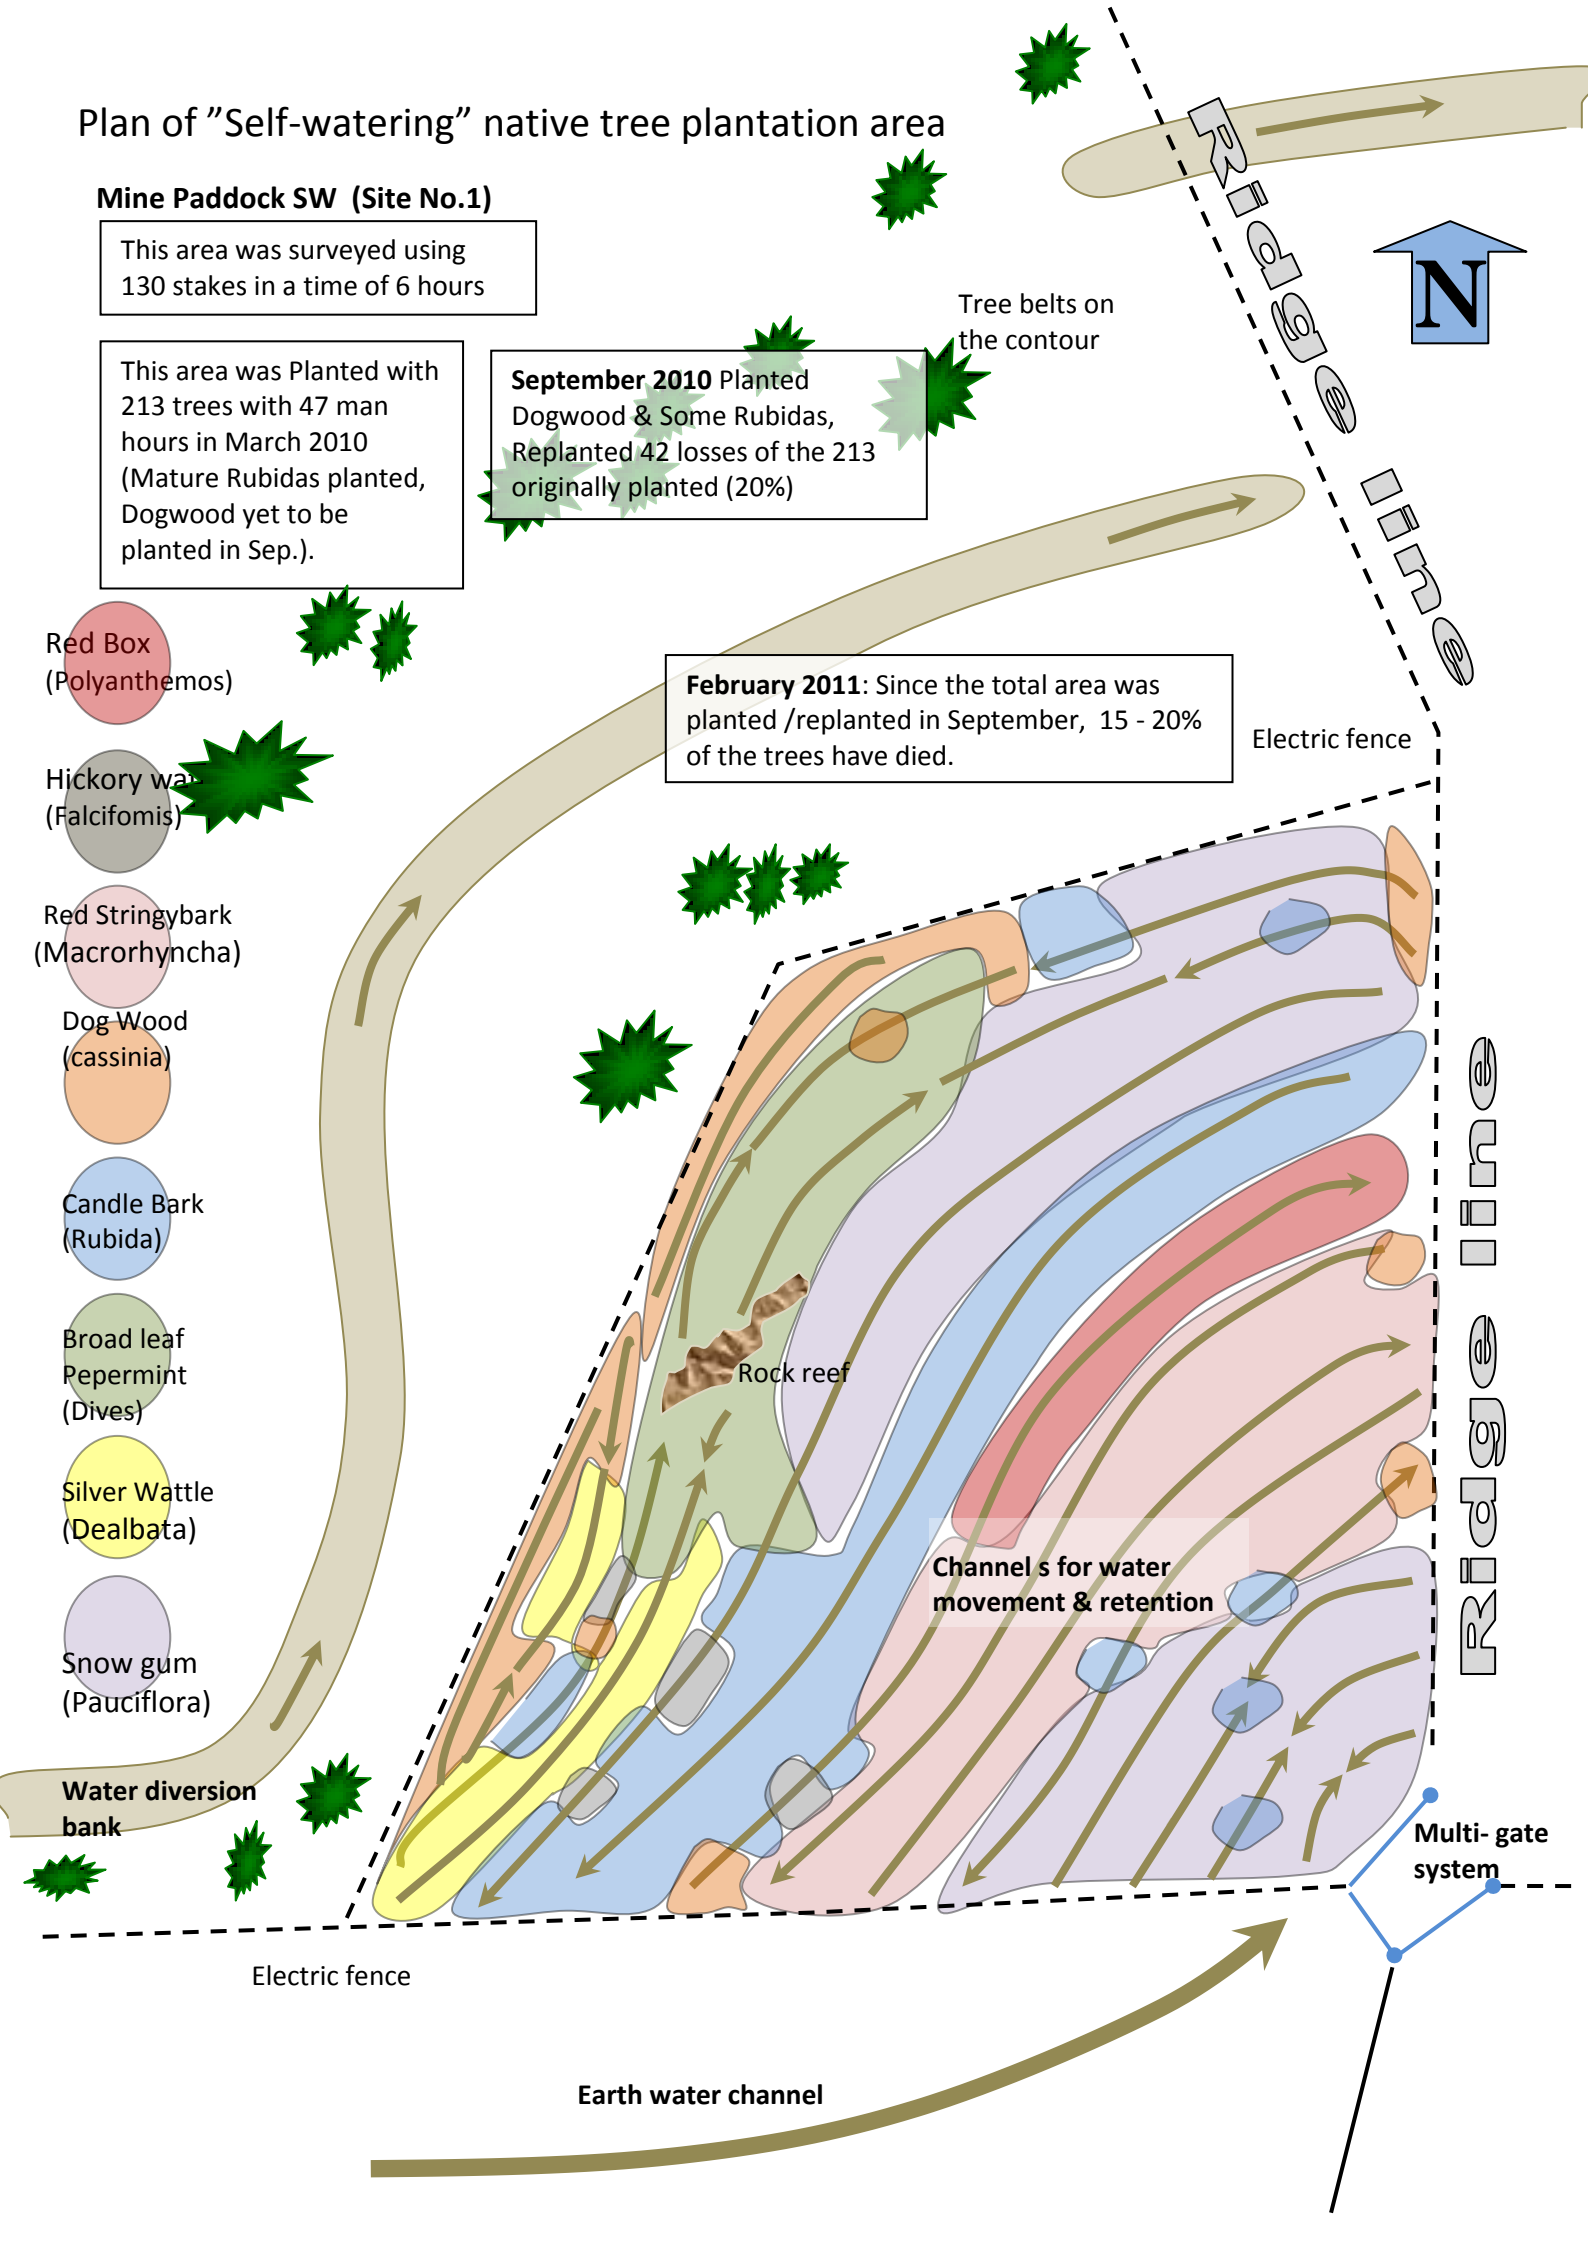
Mine Paddock SW (Site No.1)

September 2010 Planted Dogwood & Some Rubidas, Replanted 42 losses of the 213 originally planted (20%)

February 2011: Since the total area was planted /replanted in September, 15 - 20% of the trees have died.

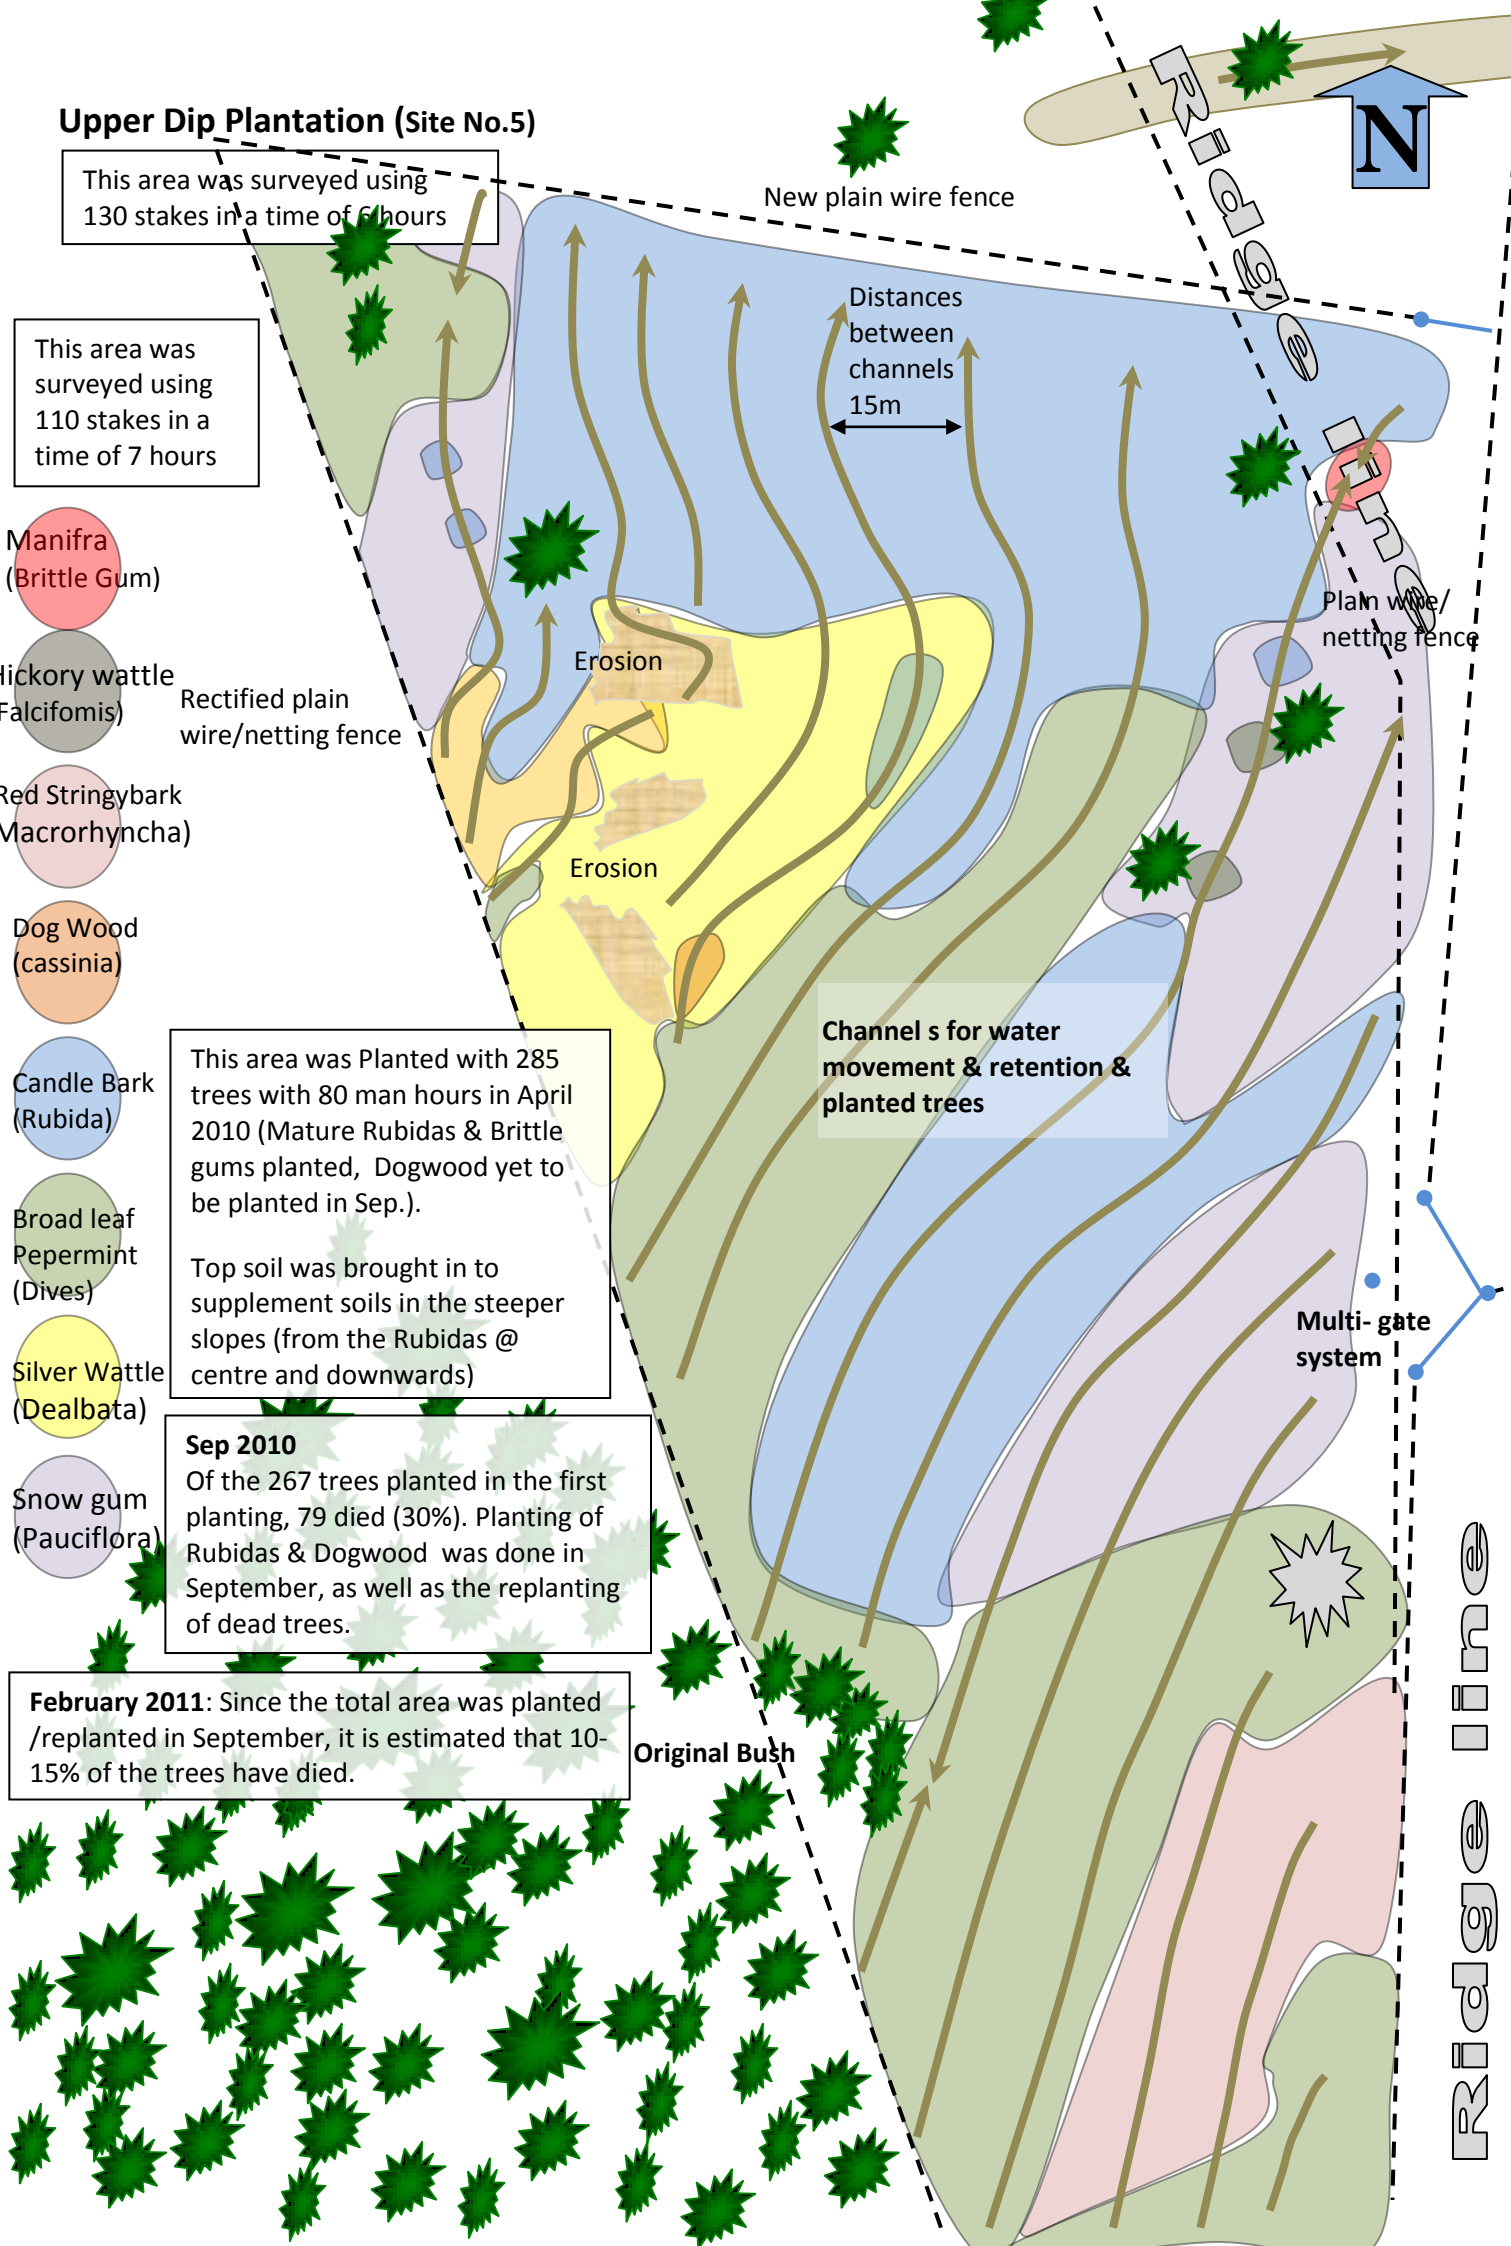
Upper Dip Plantation (Site No.5)

Sep 2010
Of the 267 trees planted in the first planting, 79 died (30%). Planting of Rubidas & Dogwood was done in September, as well as the replanting of dead trees.

February 2011: Since the total area was planted /replanted in September, it is estimated that 10-15% of the trees have died.

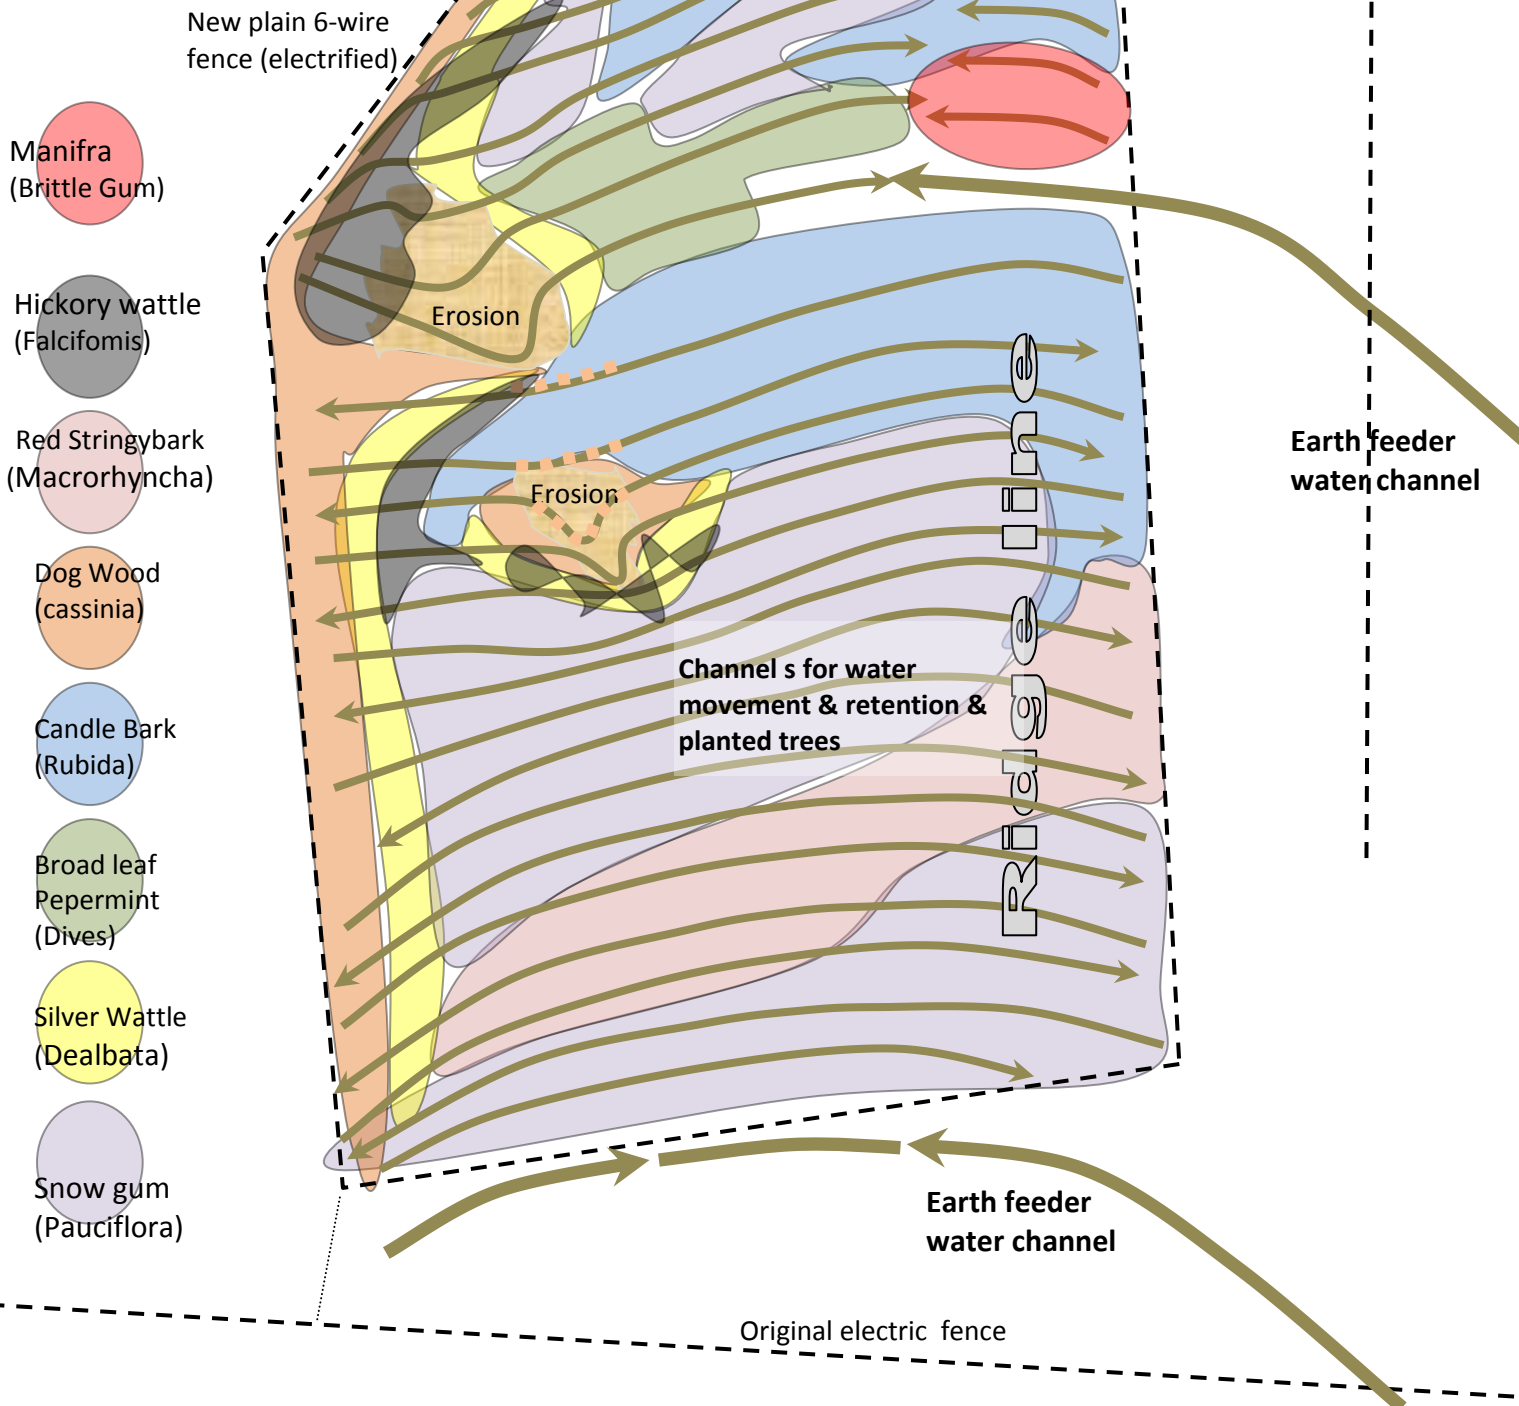
Bottom Log Plantation (Site No.4)

September 2010. Of the 300 trees planted 158 died (53%) Dead trees in this area were replanted with same species trees and the addition of Rubidas & Dogwood. All trees watered from the truck.

February 2011: Since the total area was planted /replanted in September, approximately 90% of the trees have died.

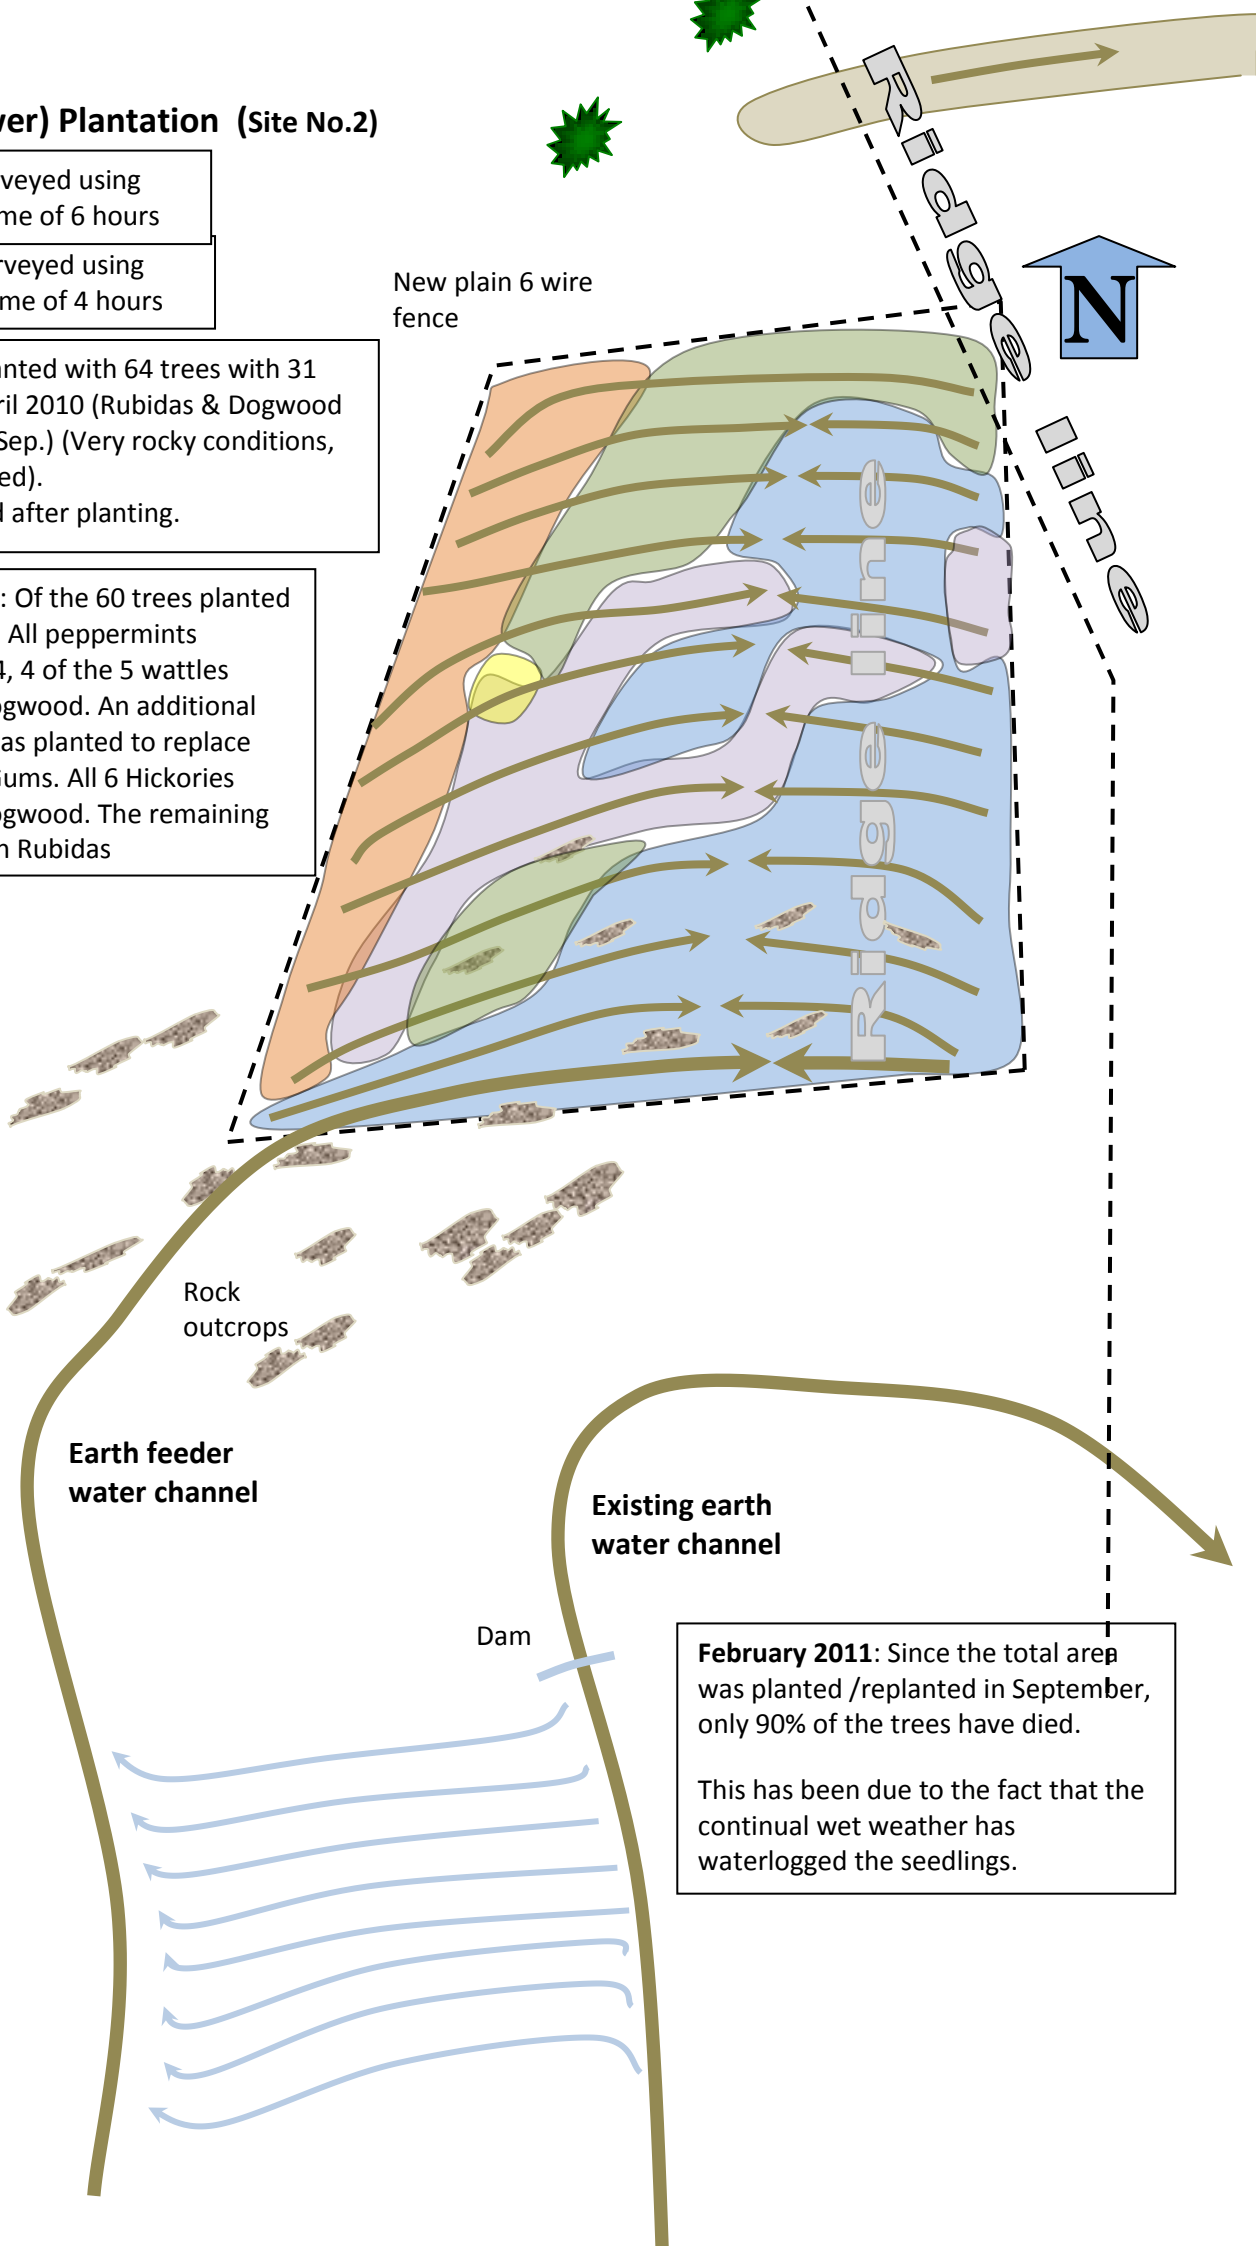
Upper Dip (lower) Plantation (Site No.2)

September 2010: Of the 60 trees planted only 15 survived. All peppermints replaced 12 of 14, 4 of the 5 wattles replaced with Dogwood. An additional number of Rubidas planted to replace the dead Snow Gums. All 6 Hickories replaced with Dogwood. The remaining area planted with Rubidas

February 2011: Since the total area was planted /replanted in September, only 90% of the trees have died. This has been due to the fact that the continual wet weather has waterlogged the seedlings.

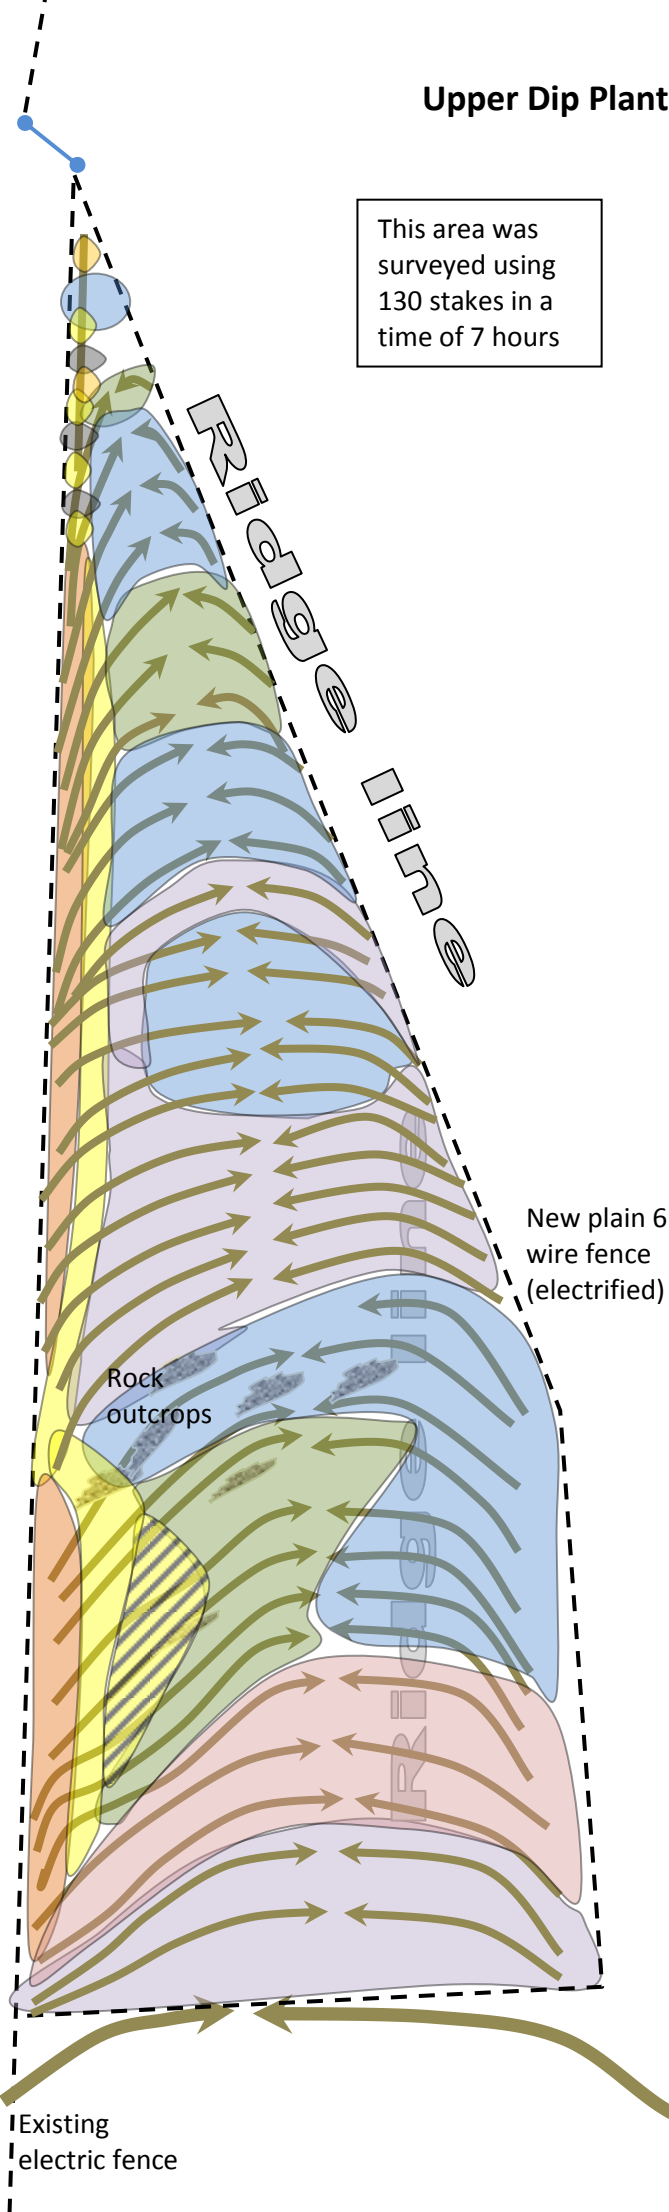
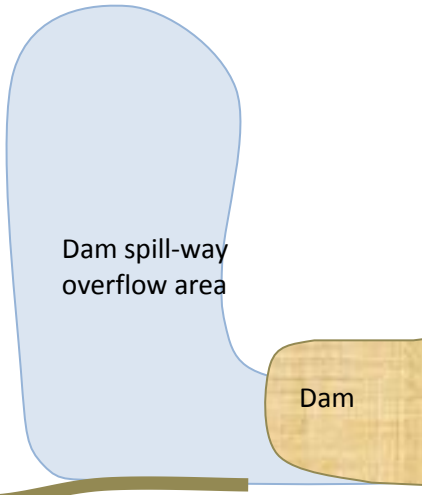
Upper Dip Plantation (dam fed system) (Site No. 3)

September 2010. Of the 148 trees planted only 38 survived. All Hickory & wattles died & were replaced with silver wattles. 78 Rubidas planted and all Dogwood. All Stringy barks, Snow gums, Silver Wattles and Broad-leaf Peppermints replanted. Channel irrigated after planting.

October 2010. Since September 9 Dogwood & 11 eucalyptus have died, all replaced with Dogwood & Rubidas respectfully. Watering of the plantation from the truck took 4 hours with 108 trees watered with one full load (1300liters) (approximately 1.5 hours / load).

February 2011: Since the total area was planted /replanted in September, 85% of the trees have died. This has been due to the fact that the continual wet weather has waterlogged the seedlings.
