Project Report

Report on completion of Landcare Project
for which in-kind work conducted:
National Landcare Program – NLP-CW-E0607/2

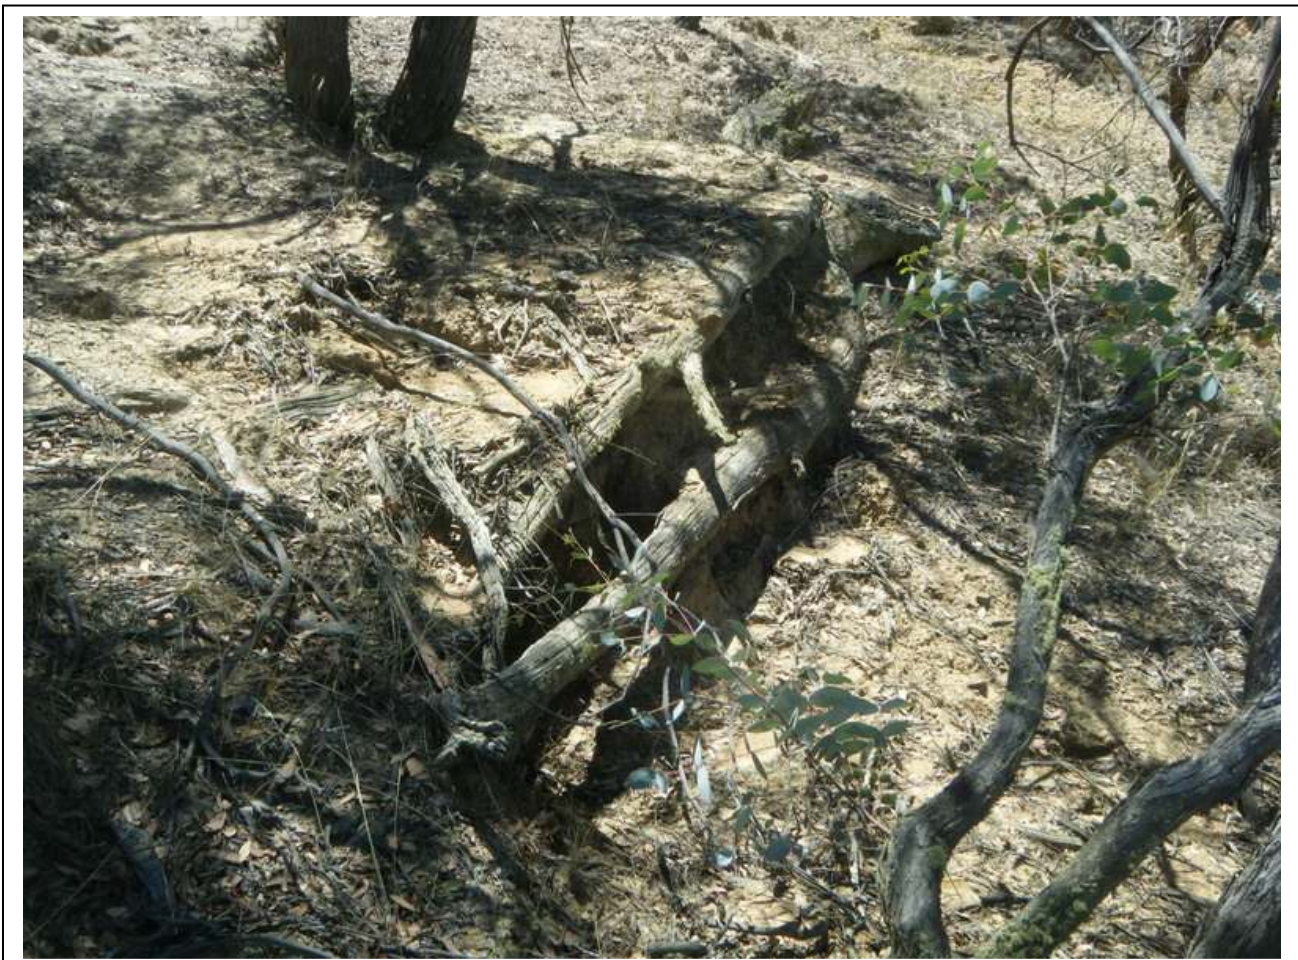
Natural sediment trap on site

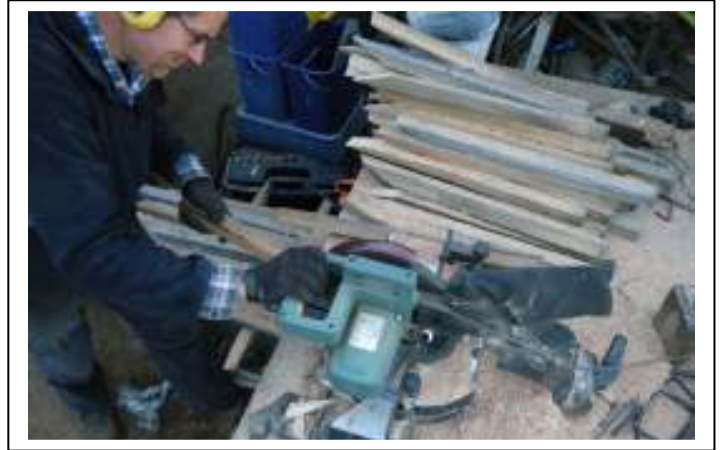
The preparations for the project included cutting the 1.8m wooden posts and steel posts to size. A variety of lengths were cut to suite the varied terrain. Steel posts for the rock areas and pointed wooden posts for the remainder.

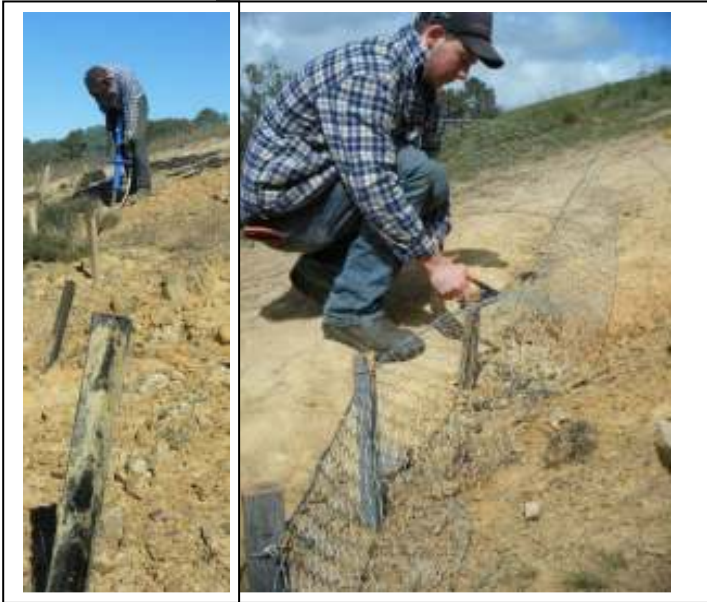
The posts were hammered into the slope, a slot cut into the top of the post (using a chainsaw) to position a top wire to which the foot netting was then fastened.

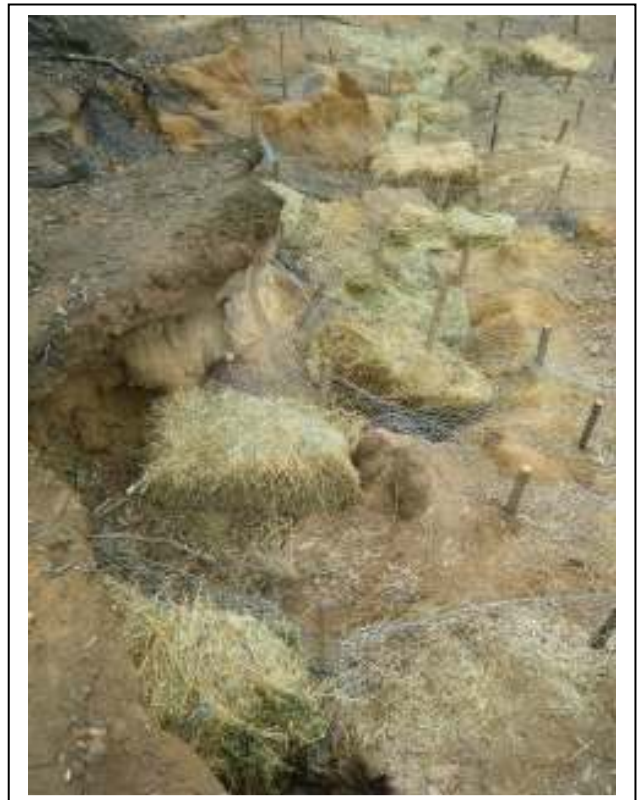
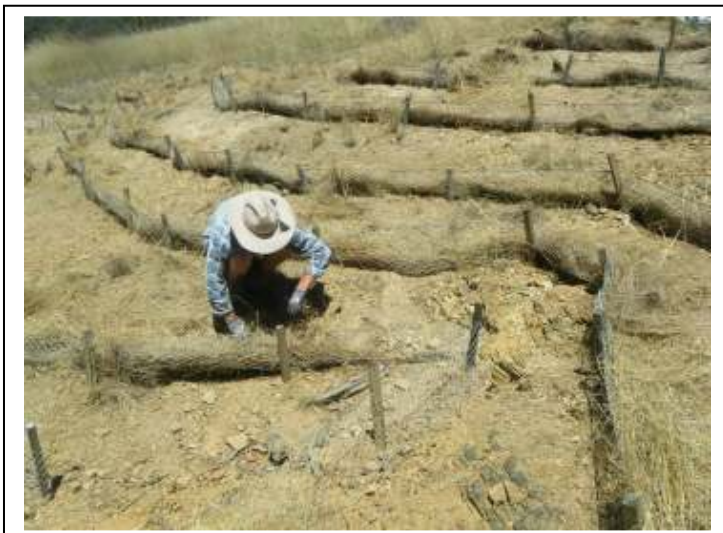
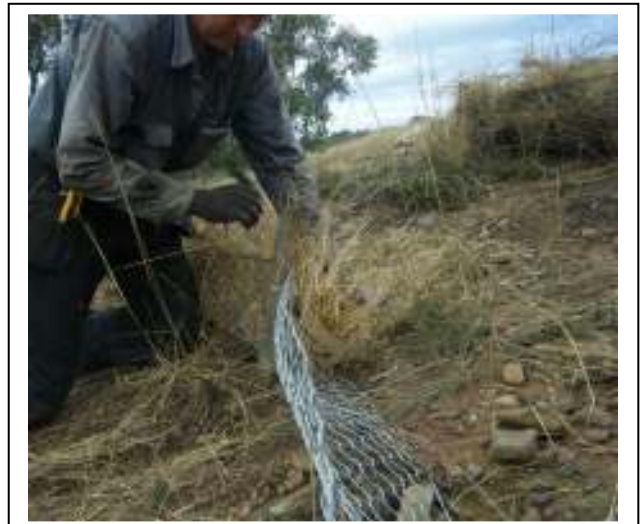
The addition of native pasture hay was not added until all the netting structures were completed. It was noted that the initial installation of the sediment traps (foot netting) that were in place for 12 months prior to the addition of pasture hay, showed very little capacity of holding/retaining the silt carried by water runoff.

Bales of hay were added to the deeper parts of the erosion areas, and then pasture hay used to fill the netted areas to better catch the finer soil particles.

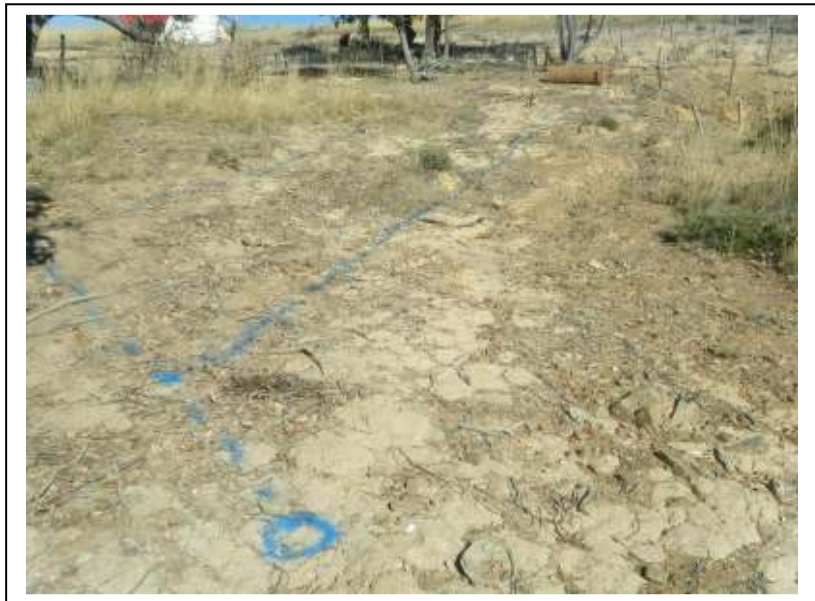
The area has been photographed prior to the treatment (see photo right).

Native pasture hay was spread on the area first and then the matting/netting pegged down with metal staples. The area was broadcast with a grass seed mixture after the installation.

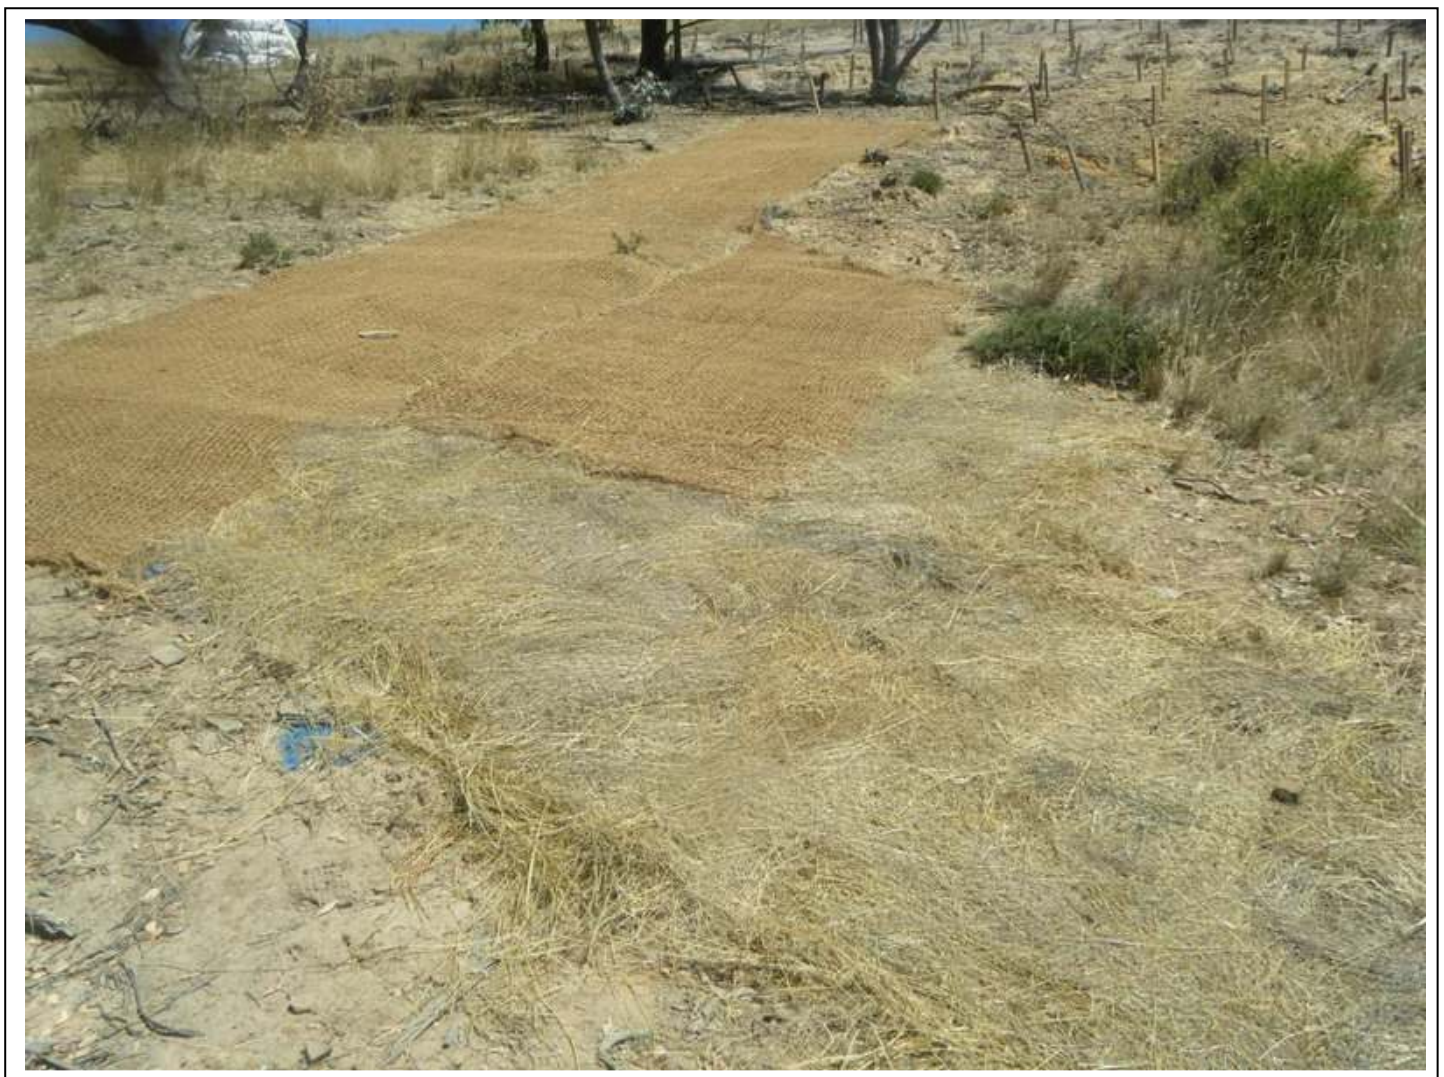
One of the completed matting structures

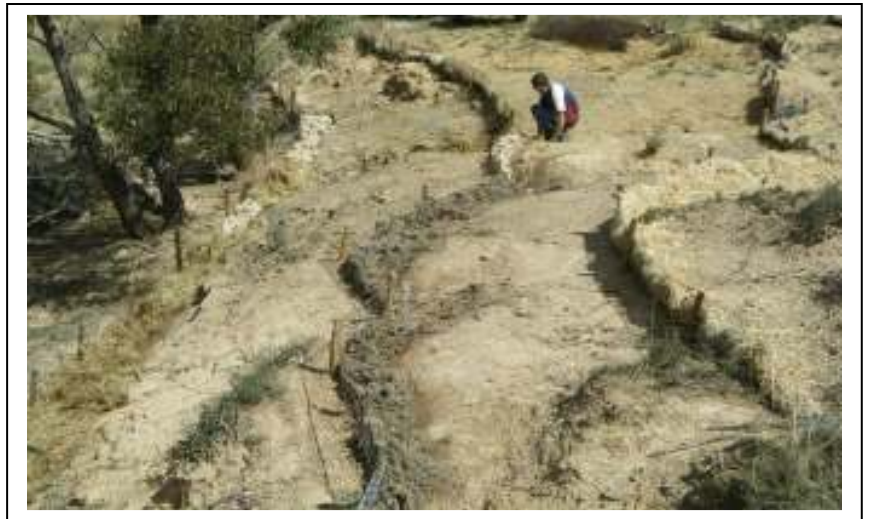
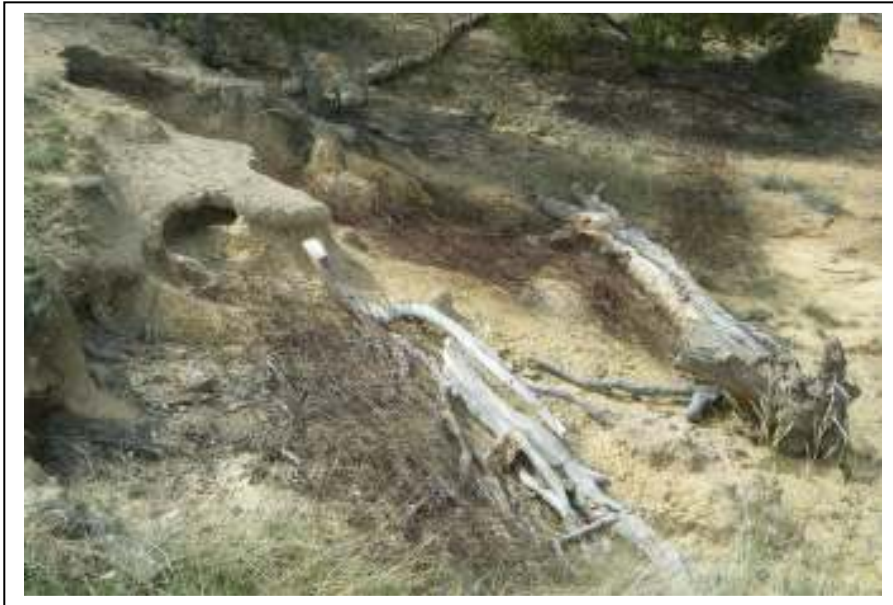
Rehabilitation of the lower eroded area was done using higher used netting with wool (contaminated waste) & slashed grass as a filler.

A nearby fallen tree was used to aid the retainment process as was old fencing material.

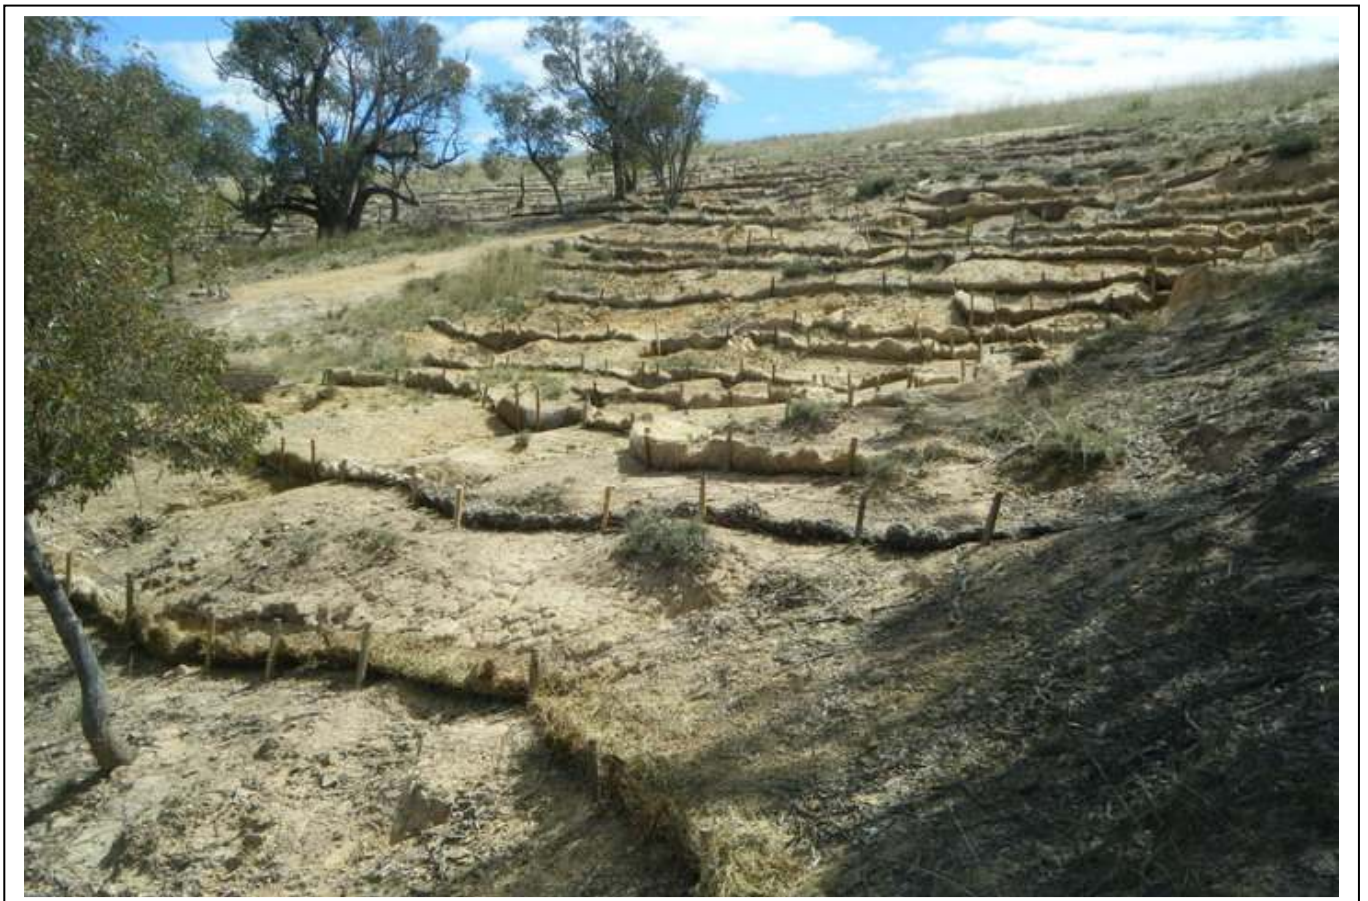
To finish the project, a grass seed mix* (financed by the local Landcare group) was broadcast over the whole area.
