# Landcare Benchmarking

Address: ..... *Knockalong, Tombong Rd, Delegate 2633* .....

## Description of debilitated area

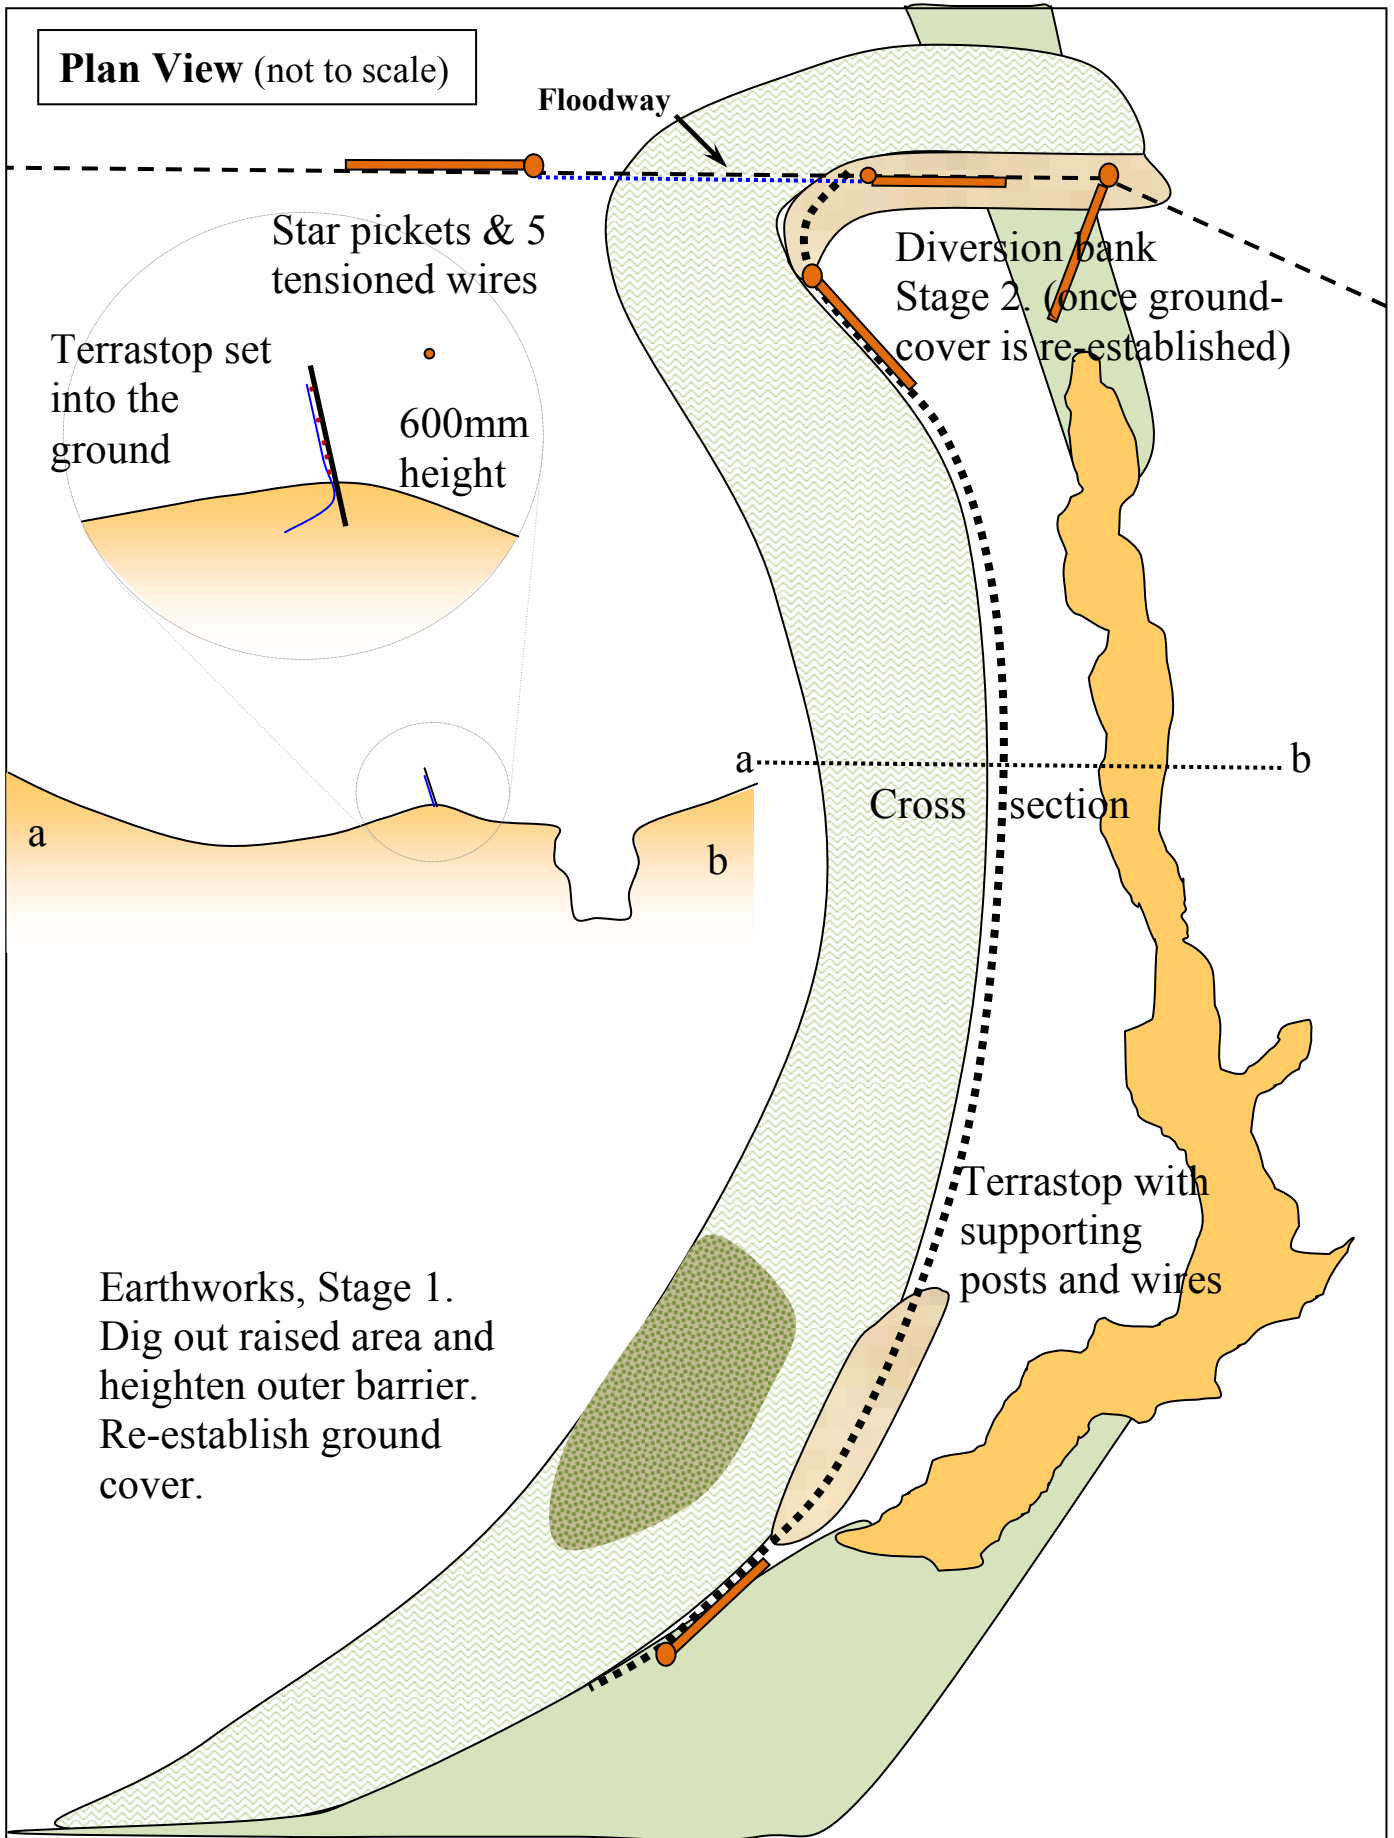
...*Active erosion gully 2 metres deep at it's head. Approximately 65 metres long. Situated 8 metres from a subdivision fence. The head of the gully is advancing an average of 1 meter per year* .....
