Project Report

Report on completion of Landcare Project for which in-kind work conducted:

Landcare – Sustainable Practices 2009/10

“Self-watering” native tree/shrub re-establishment Sites

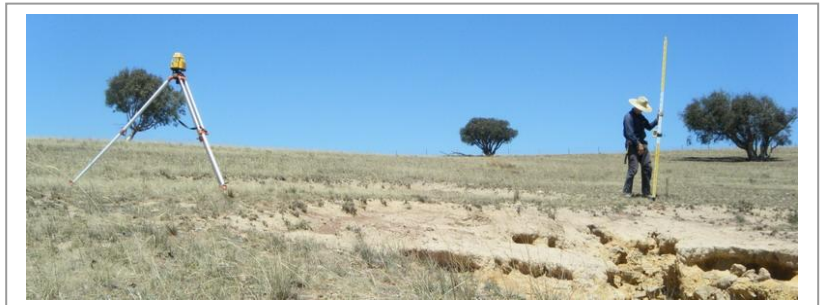
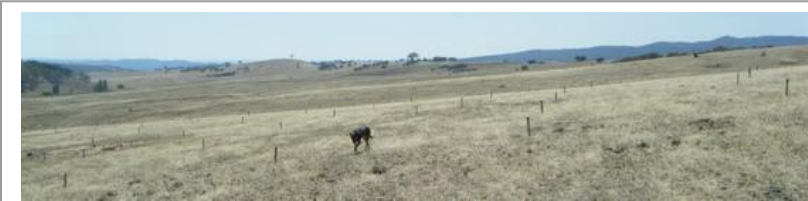
Site 4

All the sites were surveyed so as to control the flow of water both to the sites and within them. The individual site maps show the feeder channels and the site channels and their flow directions. The sites were pegged in preparation for ripping and the forming of the planting channels.

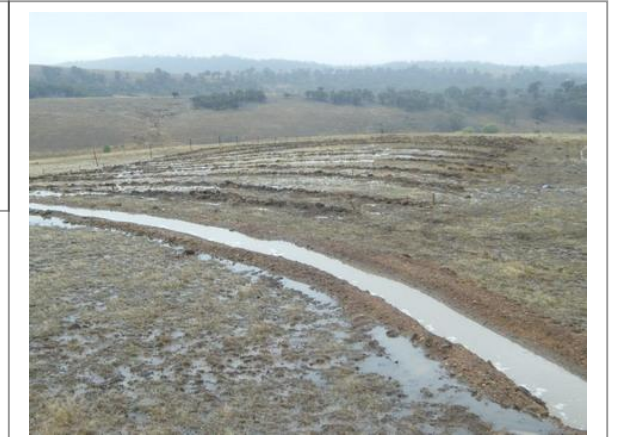
Site 3

The sites were double ripped 300mm Minimum as well as the feeder channels. The feeder channels were formed and following some wet weather so were the channels on the sites.

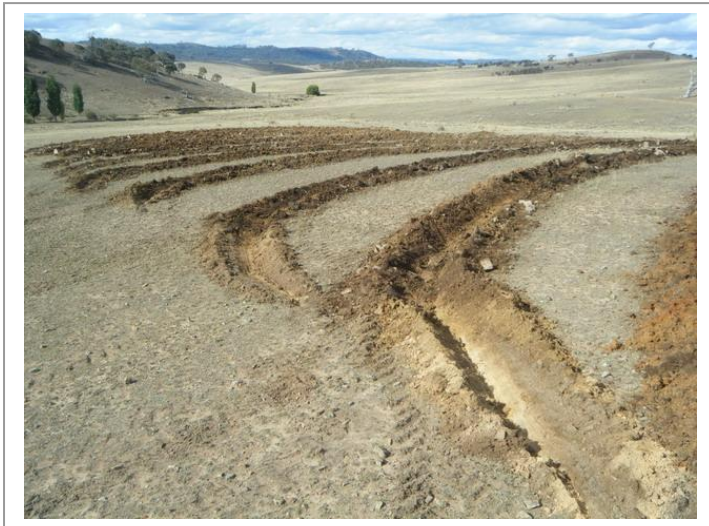
Site 2

The intent of the planting channels was to retain the water on the site and feed it from top to bottom.

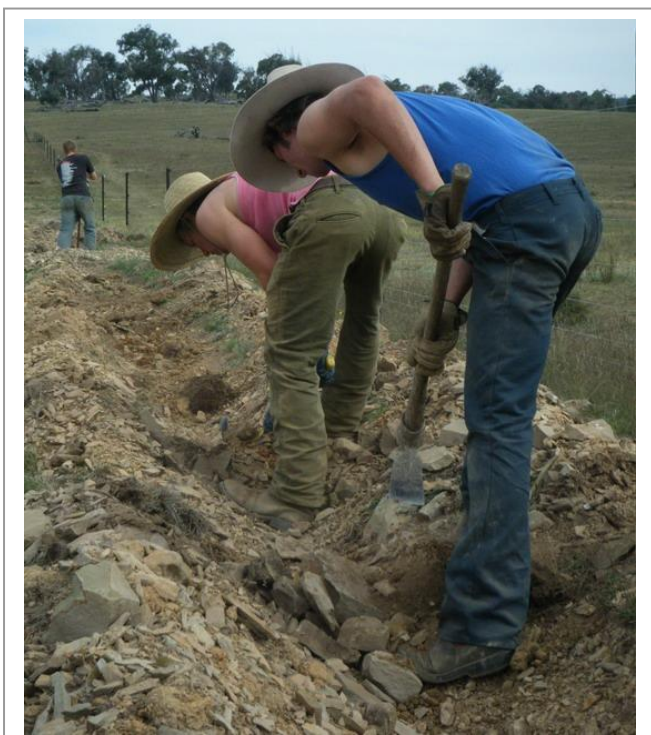
Each planting required the digging of a hole in the base of the channel, followed by the formation of the side walls that would hold the first watering (20 liters). The local ground preparations for tree planting required the addition of top soil brought in as some areas were more rock than soil.
